SAINT JOHN RIVER BASIN
Fort Fairfield, Maine

LAKE CHRISTINA DAM ME 00226

PHASE I INSPECTION REPORT NATIONAL DAM INSPECTION PROGRAM

SEPTEMBER 1981

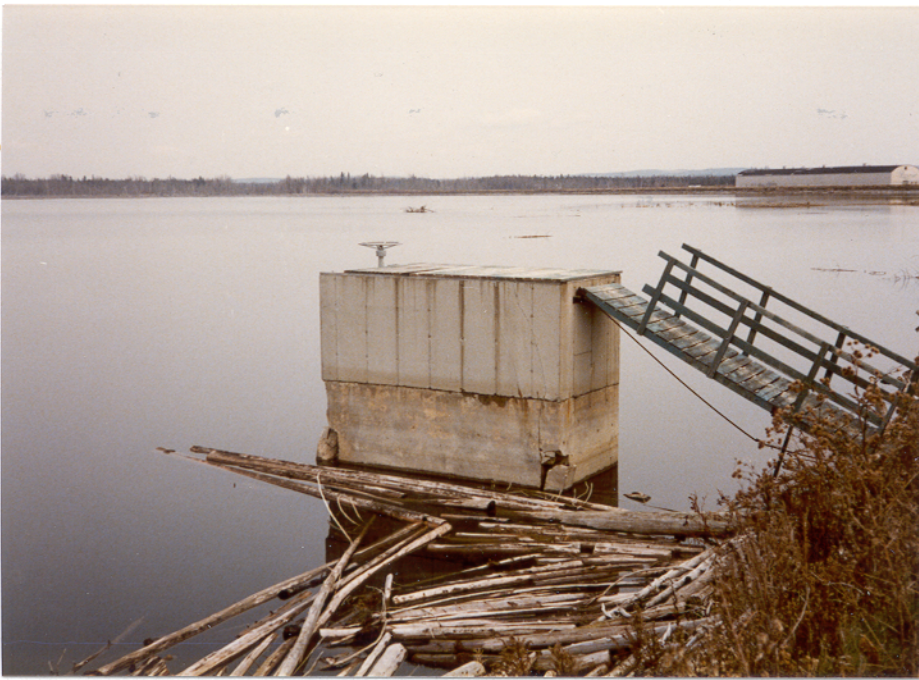
Photo 1

Drop Inlet Spillway - The concrete in the intake structure is cracked and broken on two corners (photo 1). The wooden walkway used to access the intake structure was damaged and unsafe. At the downstream toe where the outlet works discharged (photo 2 & 3), the 60" concrete conduit appeared in good condition.

A large amount of trash and debris had accumulated along the shoreline adjacent to the dam covering the rip rap. (photos 1, 7 & 8). There was no observed damage along the shoreline due to wave action or other water movement.

- a. Condition - This inspection indicates that Lake Christina Dam is in fair condition. The following points should be noted:
 - (1) The inlet structure has cracked and broken concrete and shows signs of continuous deterioration unless repaired.

- (2) The stoplogs are badly damaged and need replacing.
 - (3) The wooden walkway to access the inlet structure is damaged and unsafe. It should be repaired, replaced, or removed.

Principal Spillway
Intake Structure

- a. Repair the damaged concrete of the spillway inlet structure at the next drawdown of the reservoir.
- b. Inspect condition of rip-rap at next drawdown of reservoir.
- c. Replace damaged stoplogs at the inlet opening.
- d. Repair or replace the walkway used to access the spillway inlet structure.

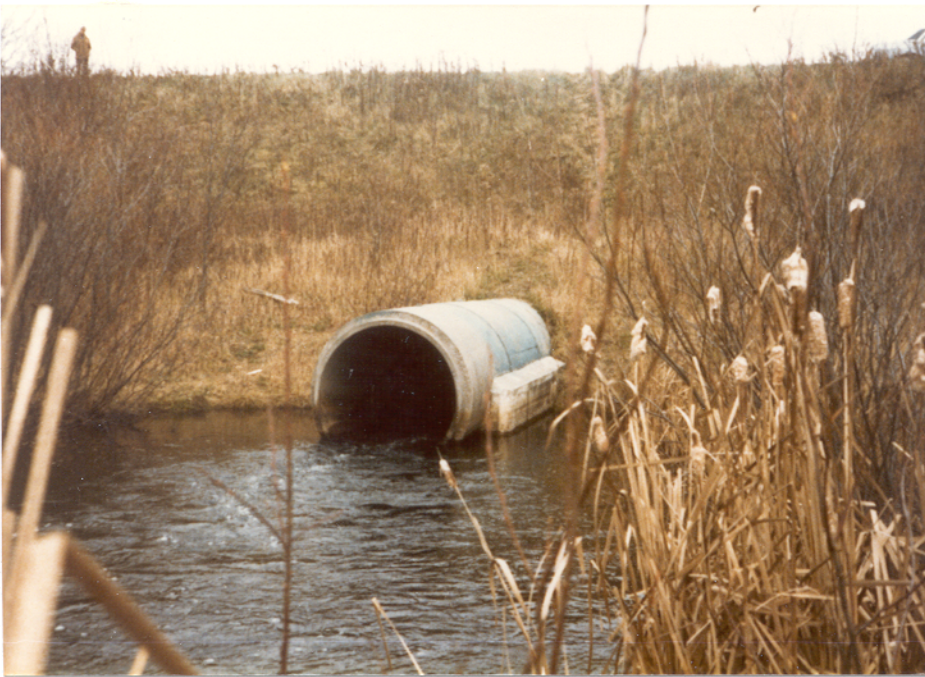
Photo 2

60" \varnothing Principal
Spillway Outlet

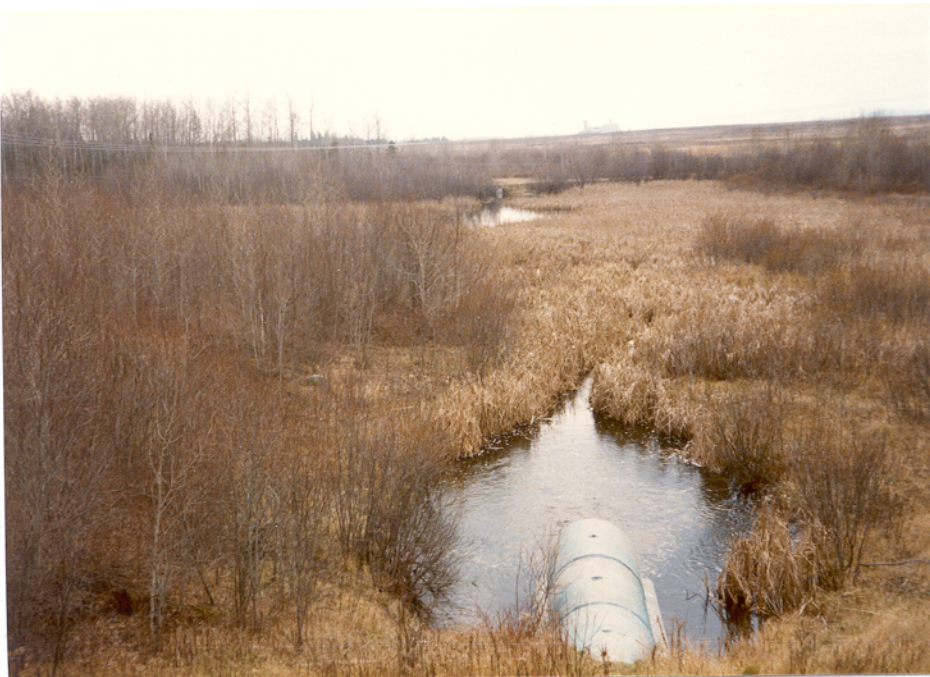
Photo 3

Principal Spillway
Downstream Channel

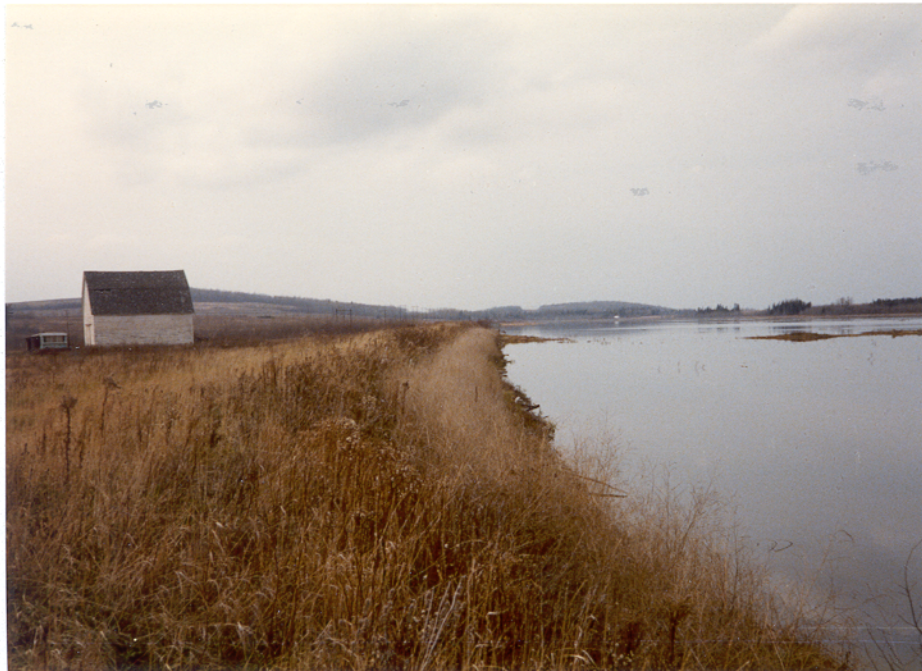
- b. Dam
 - (1) Crest - The embankment crest was true to line with no apparent dips, sags, cracks or other evidence of distress (Photos 4, 5 & 6). The crest is grass covered with no pavement. There was some water retained in ruts on the crest. The general appearance of the crest was good.

Photo 4
Upstream Slope
& Crest

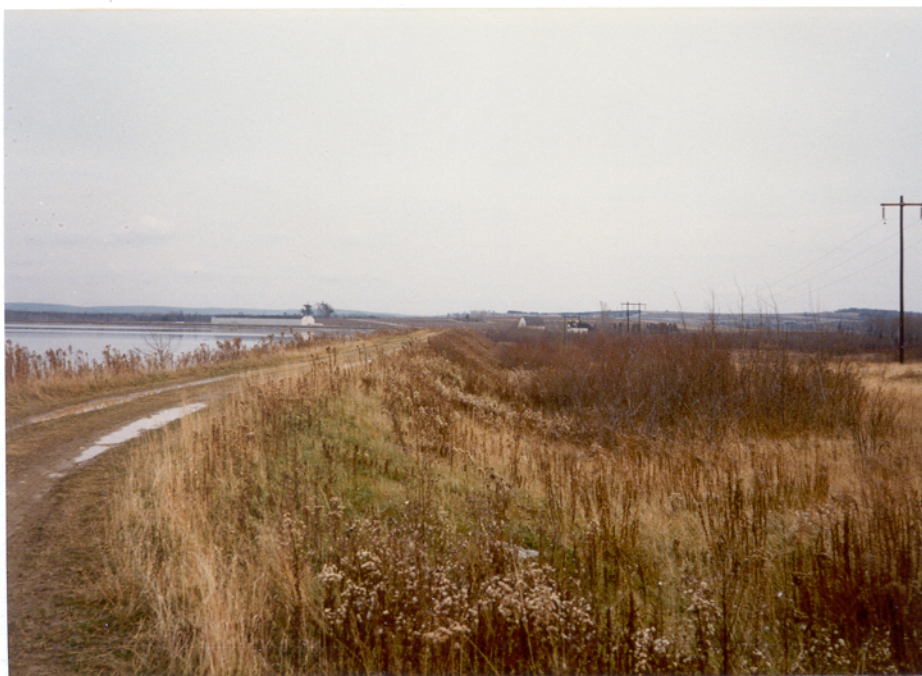
- (3) Downstream slope - The downstream slope also appeared overgrown with thick vegetation (photos 5 & 6). There was no observed erosion, sags, or slides. The general appearance of the downstream slope was fair.

Photo 5
Right Abutment
Crest & Downstream
Slope

Maintenance procedures should be established to remove the debris from the reservoir and downstream slope, remove the trees and brush from the embankments up to twenty feet beyond the downstream toe, and replace the deteriorating concrete of the intake structure.

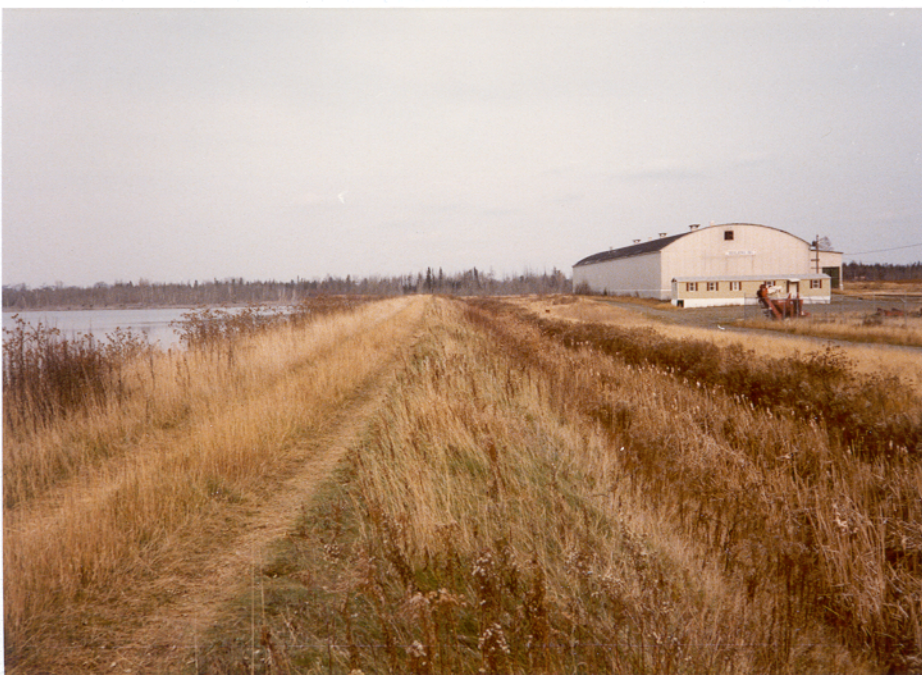
Photo 6
Left Embankment
Downstream
Slope

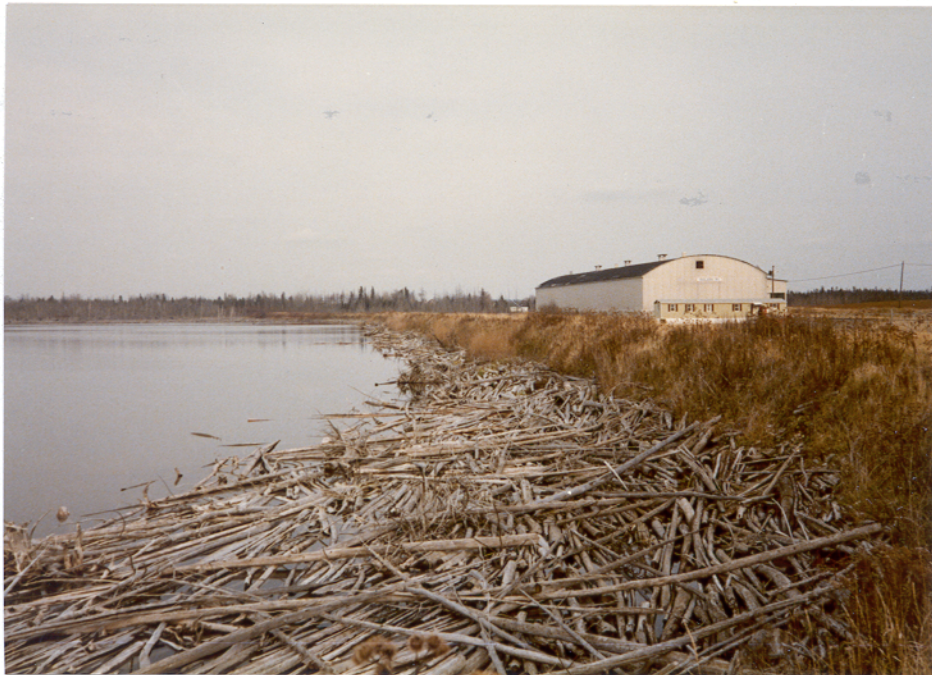
Photo 7

Trash Buildup at
Junction Left Reach
and Main Reach of
Dam

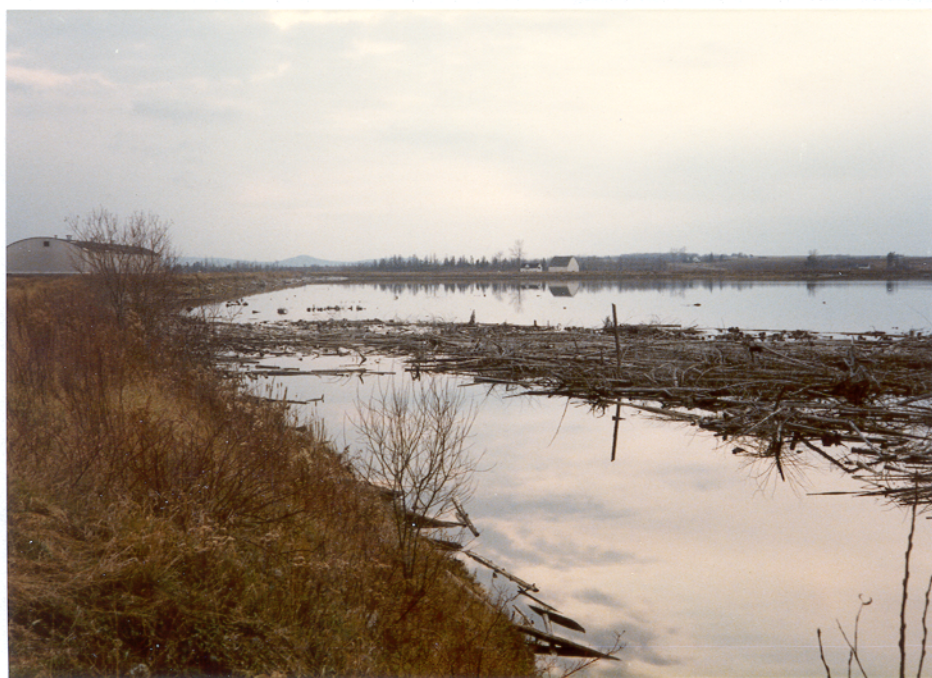
Photo 8

Trash Buildup at
Left Abutment
